Proposed Student
Accommodation, Ballybeg Drive,
Co. Waterford

Quality Audit

Document Ref:	P23106-PMCE-XX-XX-RP-QA-GEN-3_ZZ_01
----------------------	--

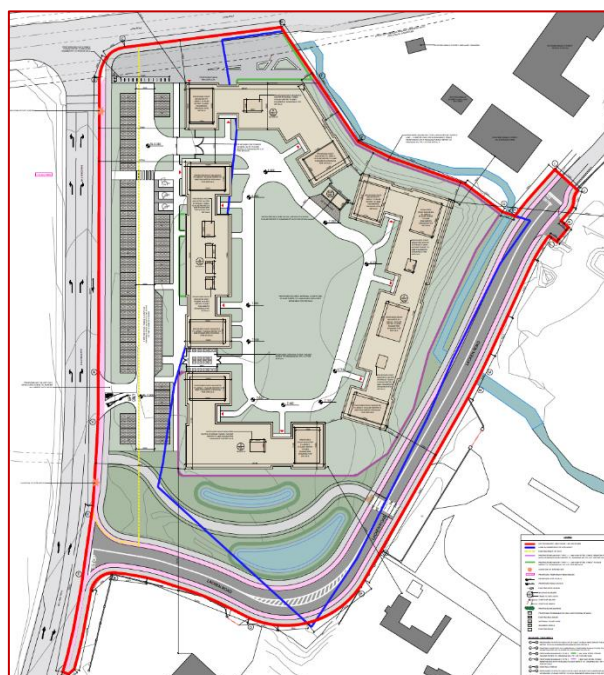
FIGURE 1.2: PROPOSED DEVELOPMENT

A secured courtyard would be located in the centre of the accommodation blocks and this would be accessible by residents of the proposed student accommodation development only, and their guests. The courtyard would be accessed by pedestrians and cyclists through the primary access located in Block A, where a reception/security desk would be located. This would be accessed from the internal footpath network within the development's carpark and would then exit to the secure courtyard, to the rear of Block A, onto the 4m wide shared path surrounding the courtyard.

A fire tender access gate is located adjacent to the primary access to Block A however this would only be used during times of an emergency, or for access for maintenance vehicles to the ESB substation, and would remain locked at all other times.

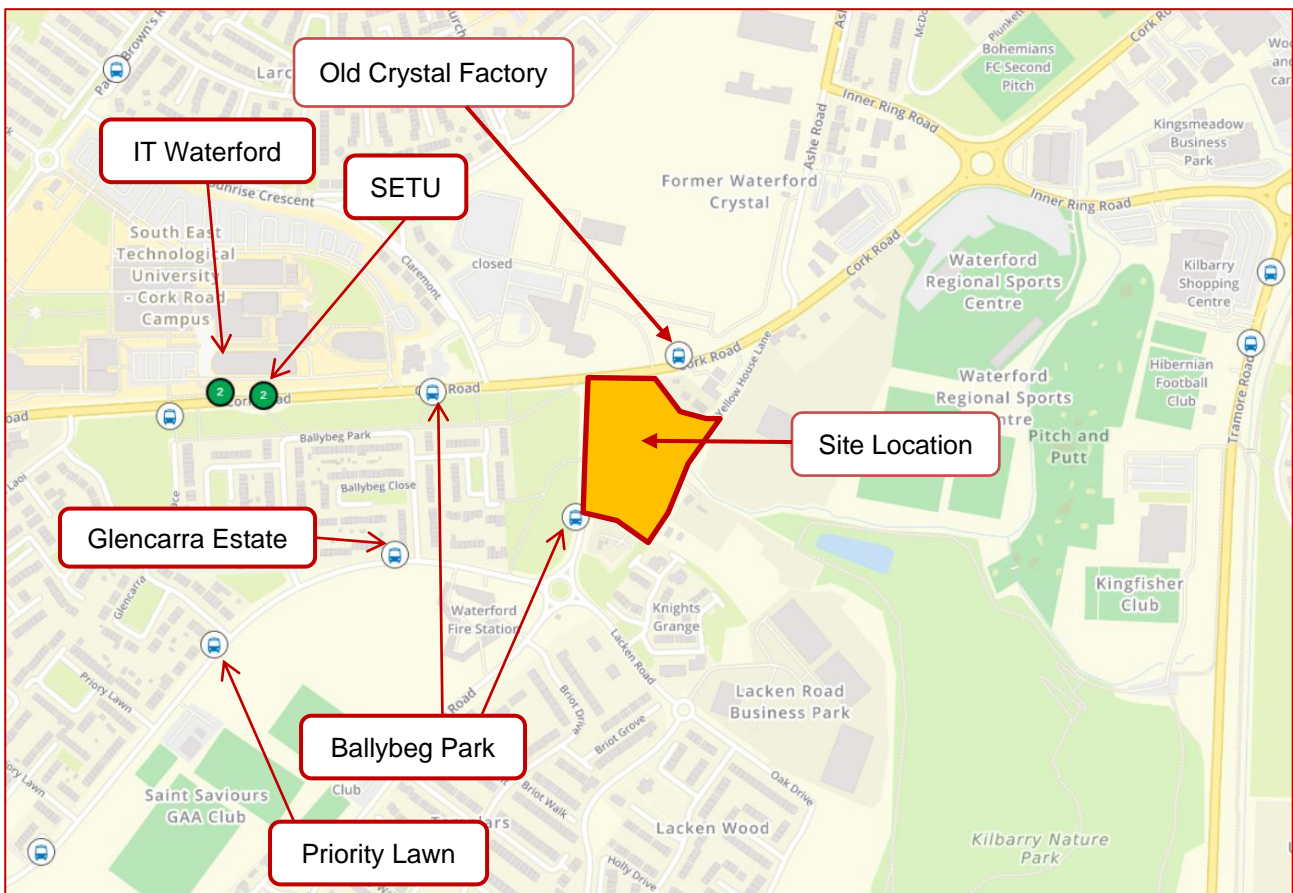
There are existing bus stops on Cork Road and Ballybeg Drive, providing direct access to the local bus network, and Cork and Dublin Airport. The Ballybeg Park Stop is located immediately adjacent to, and southeast of, the proposed development (see Figure 1.3) and can be accessed within a 1-minute walk from the site entrance of the development access on Ballybeg Drive.

The nearest bus stops to the proposed development are listed on Table 1.1 including the bus routes which serve these bus stops, and Figure 1.3 indicates the location of these bus stops in relation to the proposed development.

FIGURE 1.3: NEARBY BUS STOPS AND LUAS STOP (SOURCE: WWW.TRANSPORTFORIRELAND.IE)

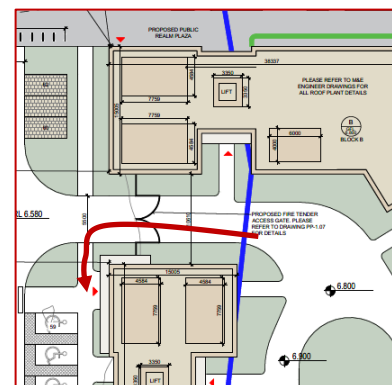
I.2.2 Connectivity between the Internal Courtyard and the Development Carpark

It is unclear from the drawings provided how the pedestrian routes within the internal courtyard will connect to facilities at the location of the primary access.

The likely pedestrian desire lines between the proposed development's internal courtyard and the pedestrian facilities at the primary access should be identified, and measures provided to cater for these desire lines safely.

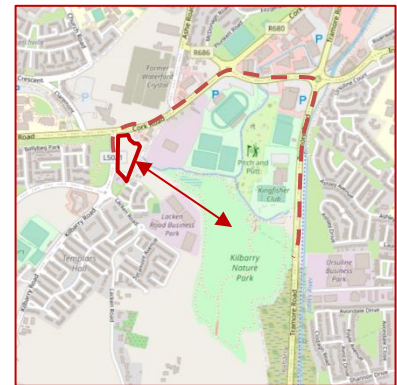
1.2.3 Connectivity to Kilbarry Nature Park

The Kilbarry Nature Park to the southeast is likely to be an attractive destination for students in the student accommodation. However, it is not clear if direct pedestrian/cycle links will be provided between the southern and eastern extents of the development and this destination, or if this pedestrian desire line will be catered for in this, or a future development phase.

The absence of this direct route may discourage pedestrians from choosing walking as a regular form of travel, as the indirect route via the Cork Road, Inner Ring Road and Tramore Road may be considered too long.

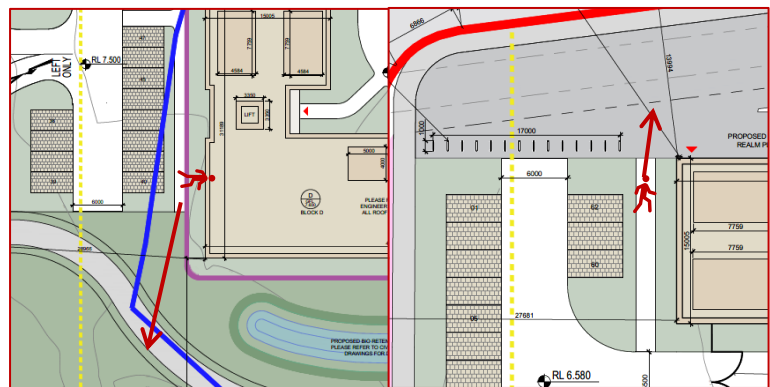
1.2.4 Pedestrian Desire Lines

The 'Green link' path runs along the southern side of the proposed student accommodation connecting the eastern footpath of Ballybeg Drive with the northern footpath of Lacken Road. The proximity of the development carpark to the green link may create a pedestrian desire line between these locations, however, no connection for pedestrians has been provided.

Similarly, a public plaza is indicated to the north of the development, however, no direct pedestrian link is provided between the development carpark and the plaza.

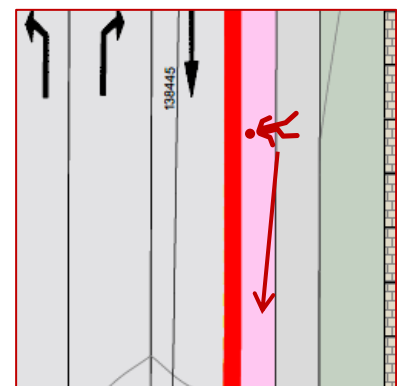
A cycle track and footpath has been indicated along both sides of Ballybeg Drive continuing to Lacken Road to the development extents. No information, however, has been provided in relation to the cross-section of the footpath/cycle track and it is, therefore, unclear if a level difference would be provided between the footpath and cycle track. The absence of a level difference may lead to visually-impaired pedestrians being insufficiently aware of the cycle track resulting in them inadvertently entering it, where there is an increased risk of being struck by a cyclist.

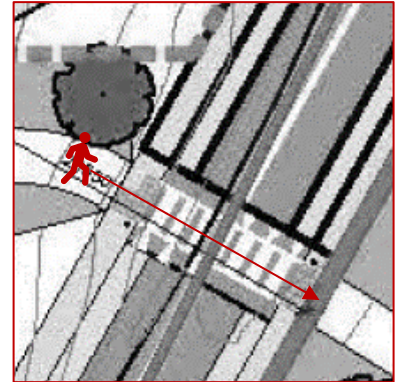
I.2.10 Inter-visibility between Road Users

Should inter-visibility between drivers and pedestrians (or cyclists) waiting at, or using, the crossing be restricted, there is a risk of drivers failing to stop.

Sufficient inter-visibility between drivers and VRUs should be provided at crossings within the proposed development.

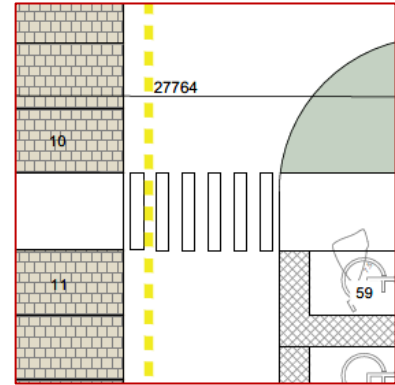
I.2.14 Carpark Crossing Details

It is assumed that the NMU routes within the proposed development are delineated from the adjacent carriageway within the carpark by a physical kerb. A dropped kerb and tactile paving have not been indicated at the pedestrian crossing within the carpark. A failure to provide a dropped kerb at crossings and at the end of NMU routes may lead to mobility impaired pedestrians experiencing difficulties descending/ascending the kerb at this location or being insufficiently aware that they are in an area shared with vehicles.

Dropped kerbs and tactile paving should be provided at the pedestrian crossing in the carpark and at locations where NMU routes exit onto shared surfaces or other areas shared with other road users.

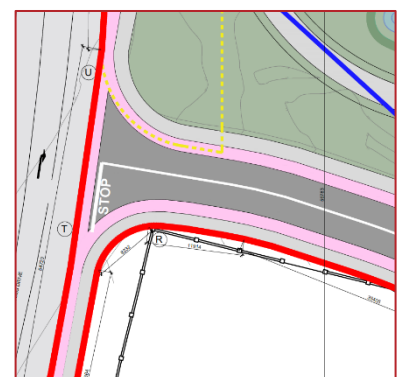
It is unclear from the information provided if the new cycle track would have vertical separation between it and the footpath & the carriageway.

If the cycle track is provided adjacent to, and at the same level as, the footpath with no vertical separation there is a risk that visually-impaired pedestrians may inadvertently enter the cycle track resulting in pedestrian-cyclist collisions.

Should the cycle track be on the same level as the carriageway, without separation from the traffic lane, there is a risk of drivers straying into the cycle lane and presenting a hazard to cyclists, or of inappropriate parking within the cycle lane requiring cyclist enter the traffic lane in order to pass the parked vehicles where they are at an increased risk of being struck by a vehicle.

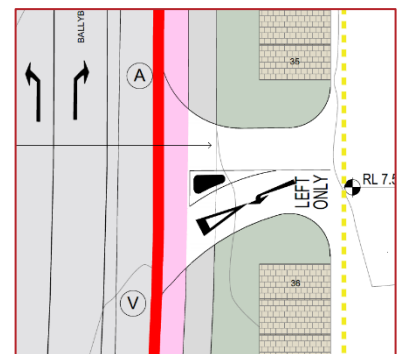
A left-in left-out junction has been indicated at the access to the proposed development on Ballybeg Drive. No pedestrian crossing has been indicated across the access. A failure to provide a crossing with dropped kerbs would lead to pedestrians having to ascend/descend a full height kerb on both sides when crossing the access. This could lead to difficulties for pedestrians, particularly the mobility-impaired, when crossing the access resulting in an increased risk of trips and falls.

If the island is not able to accommodate pedestrians waiting for a gap in traffic entering/exiting the development, there is a risk that they may encroach into either traffic lane while waiting and be struck by a vehicle.

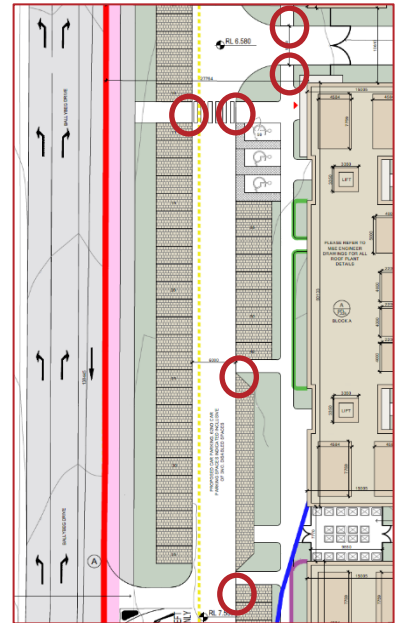
In addition, where footpaths are indicated as terminating at the edge of the carriageway opposite opposing footpaths, which are assumed to be pedestrian crossings, no dropped kerbs and tactile paving have been indicated. A failure to provide tactile paving at pedestrian crossing locations may lead to visually-impaired pedestrians inadvertently entering the carriageway and being struck by a vehicle.

Dropped kerbs, and associated tactile paving, should also be provided on both sides of pedestrian crossings proposed within the development.

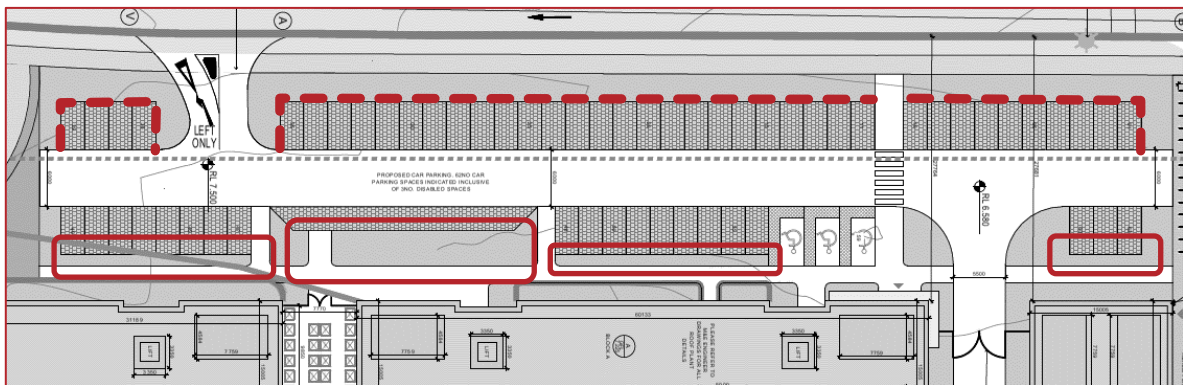
4.5 Routes between Parking Spaces/Set-Down Area and Footpaths

Summary: Footpaths have not been indicated directly adjacent to parking spaces and the set-down area within the proposed development which may lead to vehicle occupants travelling within the carriageway, or verge, to reach a footpath.

Footpaths have not been indicated adjacent to parking spaces, and the set-down area, within the proposed development. This would require vehicle occupants to travel between the accommodation building and their vehicle within the carriageway where there is an increased risk of being struck by a vehicle, or within/through the verge to a suitable pedestrian crossing/footpath where there is a risk of slips and falls, particularly during wet or icy weather.

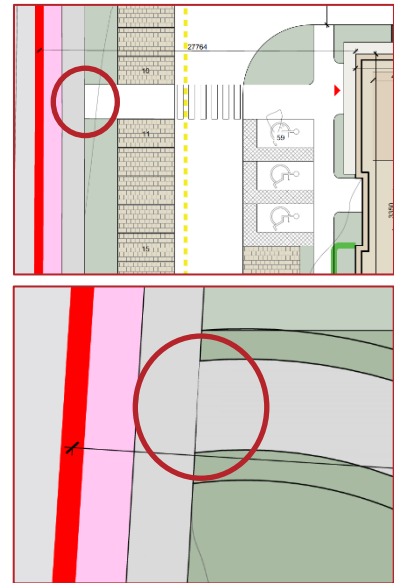
Due to the width of these paths, it is assumed that they are intended to be shared by both pedestrians and cyclists. The footpath on Ballybeg Drive is, however, not a shared path. Warning tactile paving has not been indicated at the locations where the shared paths transition to the footpath to advise visually-impaired pedestrians that they are entering/exiting an area shared with cyclists. This could lead to visually-impaired pedestrians being insufficiently aware of cyclists sharing the same space as them increasing the risk of pedestrian-cyclist collisions.

Corduroy hazard warning tactile paving should be provided within the shared paths where they transition to the footpath on Ballybeg Drive. The tactile paving should be comprised of rounded bars running transversely across the direction in which people will be walking (see Figure 16 in “Guidance on the Use of Tactile Paving Surfaces” (2021)).

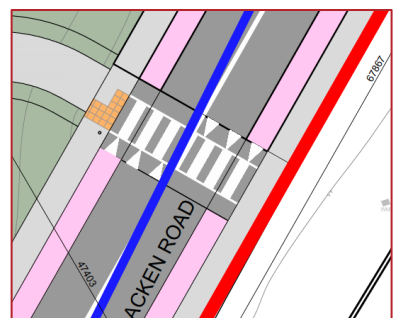
A Zebra crossing has been indicated on Lacken Road. Tactile paving has been indicated on the western side of the crossing however none has been indicated on the eastern side. This may lead to visually-impaired pedestrians travelling on the footpath on the eastern side of Lacken Road being unable to detect the tactile paving resulting in them being unable to safely and independently navigate the road layout.

In addition, the tactile paving on the western side of the crossing is not the correct colour for this type of crossing. This could lead to confusion for visually-impaired pedestrians resulting in them being insufficiently aware of the type of crossing.

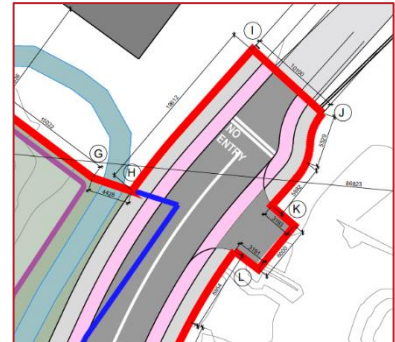
In addition, there are currently no 'No Entry' signs at the transition between the one-way and two-way sections on Lacken Road, nor are any indicated as part of the upgraded road layout. This may lead northbound drivers being insufficiently aware of the transition to the one-way section resulting in them failing to turn around at this location further increasing the risk of head-on collisions with southbound vehicles.

In addition, 'No Entry' signs should be provided on both sides of the road facing northbound drivers at the exit from the one-way section to supplement the road markings indicated.

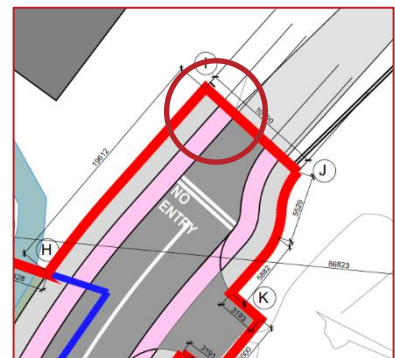
4.11 Northbound Cycle Track/Lane on Lacken Road

It is proposed to upgrade the existing road layout on Lacken Road which would include the provision of cycle tracks/lanes on both sides of the road. The northbound cycle track/lane is indicated as continuing north of the 'No Entry' road markings at the transition between the one-way and two-way sections before terminating downstream of this location. The Audit Team acknowledge that it is proposed to upgrade the section of Lacken Road to the north of this location as part of a separate scheme however, should this development and these upgrades be implemented prior to the upgrades further north on Lacken Road, this would lead to northbound cyclists being directed to enter the carriageway within the one-way section where traffic travels in a north-to-south direction, increasing the risk of head-on collisions with southbound vehicles.

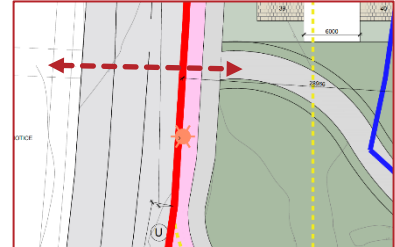
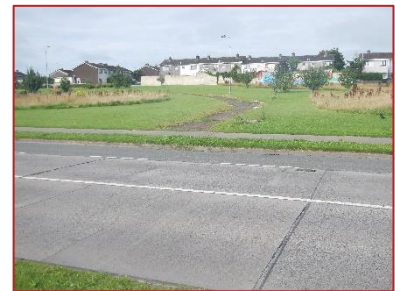
In addition, should pedestrians and cyclists cross Ballybeg Drive at this location, they would have to ascend/descend full height kerbs where there is a risk of trips and falls for pedestrians or loss of control type incidents for cyclists and falls from their bicycle.

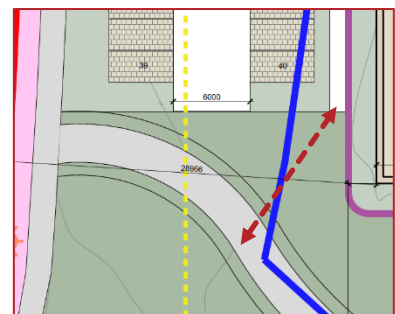
If a footpath is not provided between these locations this could lead to pedestrians and cyclists travelling through the grass area between these points where there is a risk of slips and falls, particularly during wet and icy weather.

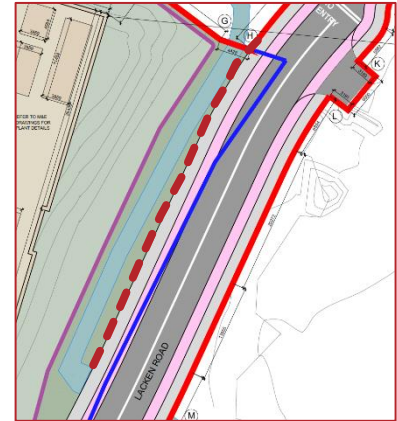
The proposed upgrades on Lacken Road will likely lead to the existing stream being more exposed and there is a risk that, should the embankment adjacent to the stream be steep, an inattentive pedestrian, or young child, may fall from the footpath and enter the stream where there is a risk of drowning.

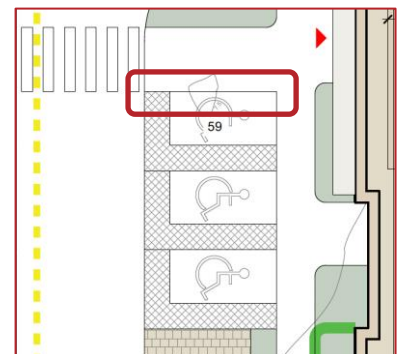
5.3 The northernmost mobility parking space within the proposed development's carpark does not include a buffer zone on its northern side. Mobility parking spaces typically require a buffer zone on both sides of the parking space. A failure to provide a buffer zone on the northern side of the northernmost space may lead to mobility-impaired vehicle occupants having insufficient space adjacent to the parking space to enter/exit their vehicles. Buffer zones should be provided on both sides of all mobility parking spaces as indicated in Figure 7.27 in the Traffic Signs Manual.

In addition, the provision of dropped kerbs and associated tactile paving adjacent to mobility-impaired parking spaces should be considered during the detailed design stage.
